Title: **Condition Assessment And Service Life Estimates For Rock Reinforcement:  
Case Study**

**By Richard Lane and Kenneth Fishman**

Abstract. Thirty-year old rock reinforcements at the Barron Mountain rock cut along I-93 near Woodstock, NH are the subject of condition assessment and estimation of remaining service-life. Two types of rock reinforcements are installed at Barron Mountain including: (1) partially bonded, resin grouted, prestressed rock bolts, and (2) fully bonded, Portland cement grouted, passive tendons. Phase I of the condition assessment includes an evaluation of site conditions, a review of installation details, estimation of remaining service life and conducting nondestructive testing. The second phase of the project (Phase II) includes lift-off tests; and physical, chemical and metallurgical testing on steel and grout samples retrieved from exhumed reinforcements. Results from Phase II are used to verify results from NDT obtained in Phase I.

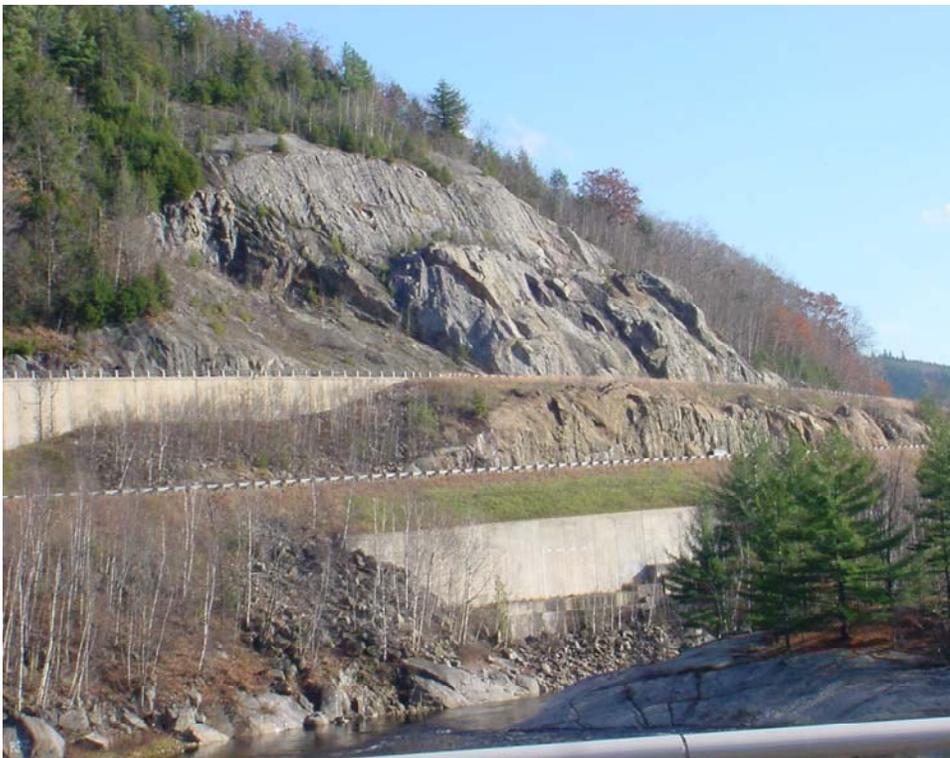
**FIGURE 1. Barron Mountain Rock Cut**

The rock cut, shown in Figure 1, reaches a maximum height of 130 ft (39.6 m), is 600± ft (182 m) in length and has a 30 ft (9.1 m) wide rock bench at approximately 90 ft (27.4 m) above ditch

elevation along the southern portion of the cut. The southern half of the rock cut (right side of Figure 1) is composed of gneiss, which grades into foliated, quartz mica schist in the northern section. A large andesite dyke, exposed along the entire height of the cut, intrudes into the country rock along the contact between the two rock formations. Smaller basalt dykes are visible on the rock face. The rockslide occurred along a highly fractured, mylonite zone, which dips toward the road at approximately 38 degrees (Fowler, 1976a and 1976b). The failure surface from the 1972 rockslide is visible in the lower left corner of the rock slope as shown in Figure 1.

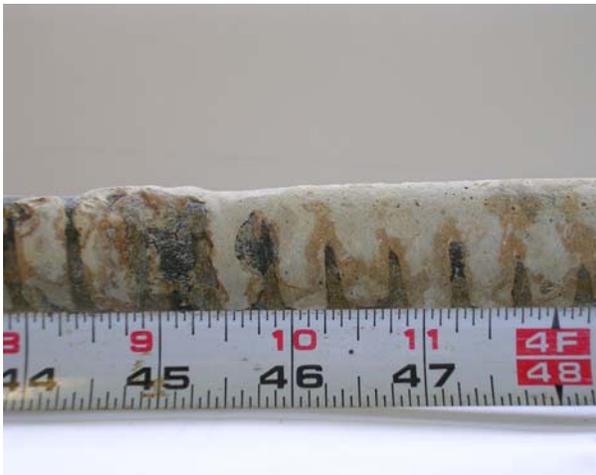
Bolt #6 and Tendon 2-4 (Figures 5 and 6) were the only exhumed samples that included grout that could be compared with electrochemical measurements included in the Phase I NDT. The half-cell potential and polarization measurements for Bolt #6 indicate that the element is likely corroded and the grout condition is questionable. The distal end of Bolt #6 did not appear to be completely surrounded with grout and corrosion was evident, which is consistent with the results from NDT.

**FIGURE 5. Rock Bolt # 6 With Resin Grout And Some Rust Staining Along Bonded Length.**

Impact test data from Bolt #6 included a relatively strong reflection from the distal end of the bolt corresponding to poor grout quality observed from the exhumed sample. Also, Bolt #16 was recovered when a loose block of rock was removed from the rock face. The results from analysis of the fracture surface were consistent with occurrence of stress corrosion cracking. Evaluation of test data from Bolt #16, indicates that a preexisting fracture surface at 4 ft (1.2 m) from the proximal end of the bolt may be evident in the impact test data. However, these reflections are very subtle and could easily be overlooked without knowledge of the existence of this fracture surface.

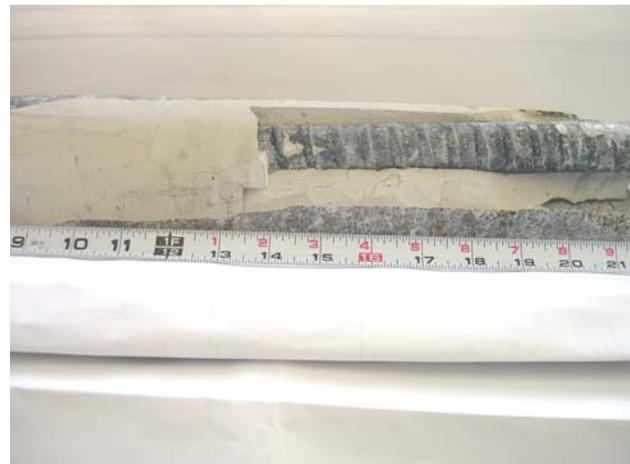
Half-cell potential and polarization measurements for Tendon 2-4 also indicate that grout condition is questionable and that corrosion is likely. The measured porosity of the Portland cement grout is approximately 35%, which contributes to a high capacity for absorption of water and possible intrusion of chlorides. The high porosity observed for the exhumed grout sample tends to confirm the interpretation of grout quality from the results of NDT. Elevated levels of chloride were detected using the procedure described by AASHTO T 260, but the detected levels were still below 0.1% often associated with initiation of corrosion in reinforced concrete. Chlorides may be present along the rock face as a residue from salt spray produced from deicing of the highway. In general, the exhumed tendon element (Tendon 2-4), which was protected by Portland cement grout, was in very good condition compared to the resin grouted rock bolt (Rock bolt #6), and this is consistent with observations from NDT.

**FIGURE 6. Tendon Element 2-4 With Portland Cement Grout Retrieved Near Proximal End.**

Considering the possibility of chloride intrusion into the Portland cement grout, we recommend that passive tendon elements be monitored at approximately 5-year intervals to check the veracity of the remaining service life estimate. Monitoring should include measurement of half-cell potential to document that these are still in the range associated with passivated steel elements. If the measured half-cell potentials are below -350 mV, then further evaluation and remediation, or replacement, of these elements may become necessary.

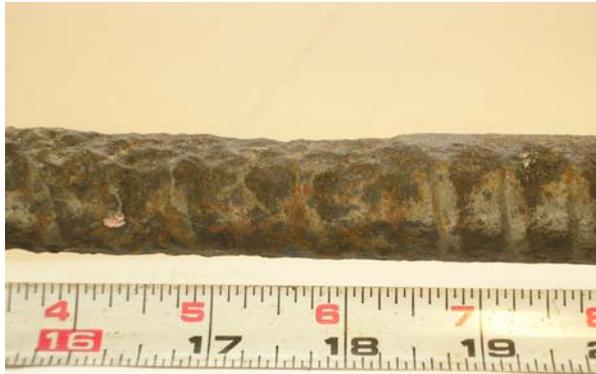
Loss of section from corrosion was observed behind the anchor plate, as shown in Figure 7(a), for three out of four rock bolt samples that were exhumed. This corrosion was not detected with electrochemical tests because the free lengths of the bolts were not in contact with the surrounding rock mass as shown schematically in Figure 2. Given the details of the anchor head assembly, reflections from a loss of section directly behind the anchor plate are difficult to identify from results of ultrasonic testing. This is because the data are masked by a strong reflection from the anchor head location. Approximately 20% loss of section is needed to produce a recognizable reflection and baseline measurements are needed to facilitate

**FIGURE 7a). Loss of Cross Section Observed Behind Bearing Plate for Bolt #4**

Pits and craters were observed at a number of locations along the rock bolt samples, and craters appear to coalesce into areas of uniform corrosion extending for lengths of approximately 4 in (102 mm) (Figure 7(a)). Pit depth measurements were obtained at 178 locations along the surface of the rock bolt samples. Pit depths were measured with a pit depth gage having a sensitivity of 0.0001 in (2.5  $\mu$ m). The average measured pit depth was approximately 0.015 in (0.38 mm) with a standard deviation of 0.014. The maximum measured pit depth was 0.1 in (2.5 mm) and 10% of the measured pit depths were greater than 0.031 in (0.79 mm). We observed that deeper pits were often associated with larger pit diameters, supporting the notion that pitted areas coalesce into areas of uniform corrosion.

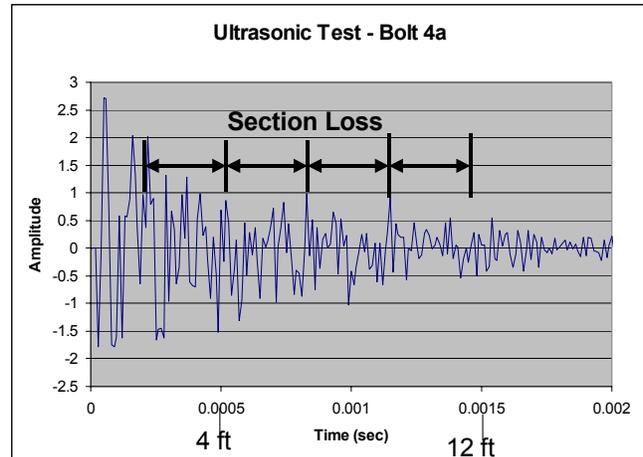
**FIGURE 7(b). Waveform form Ultrasonic Testing on Bolt #4.**

interpretation of the signal, and to verify the measurement precision. Results from the ultrasonic test on Bolt #4 are shown in Figure 7(b) and a relatively subtle reflection approximately 2 ft (0.6 m) from the end of the element is evident corresponding to the area where significant loss of cross section (approximately 20%) is observed.
