**Title: Corrosion in an Arid Environment and Condition Assessment
of a 20-Year Old MSEW**

By K. L. Fishman, J. M. Salazar and H. K. Hilfiker

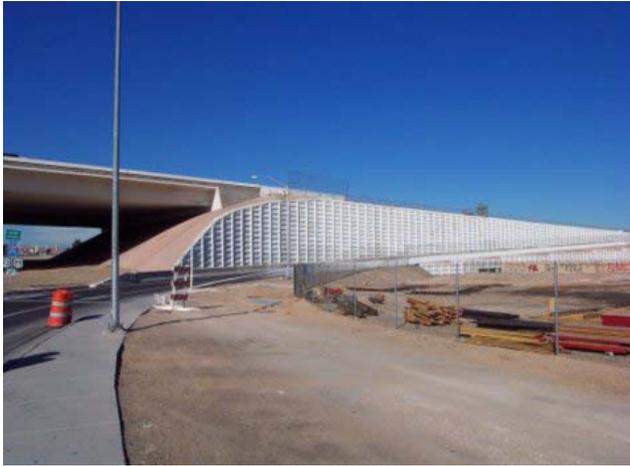
Three MSE walls are identified in Figures 2 (a) and (b) including Walls #1 and #2 along the Northbound Flamingo Road on-ramp, and Wall #3, which supports the highway embankment along the east side of the I-515, north of Wall #1. Wall #1 supports the approach to the I-515 viaduct crossing Flamingo Road. Wall #2 is beneath Wall #1 and supports the northbound on-ramp from Flamingo Road. Although the height of Wall #3 is less than twelve feet, the wall supports a sloping backfill that extends twenty to thirty feet above the top of the wall facing to the crest of the embankment. Wall #1 is the largest of the three at 800 feet long with a maximum height of 32 feet and soil reinforcement lengths that vary from 11 feet to 23 feet.

FIGURE 2(a). Wall # 1 Supporting Bridge Approach and Wall #2 Supporting On Ramp at I-515/Flamingo Rd.

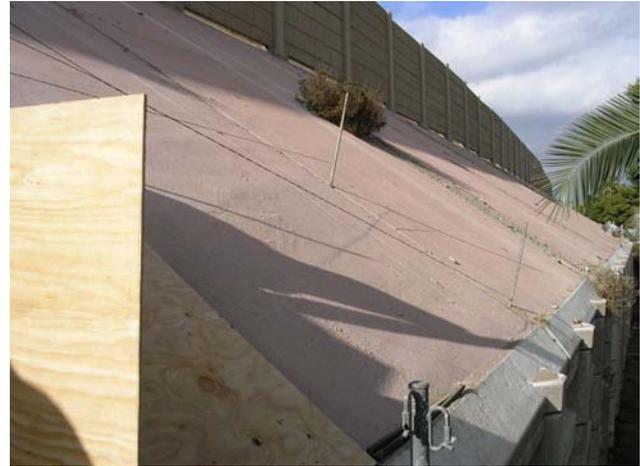
FIGURE 2(b). Wall #3 Supporting I-515 Embankment North of Flamingo Rd. On Ramp.
