Title: **Condition Assessment And Service Life Estimates For Rock Reinforcement:  
Case Study**

**By Richard Lane and Kenneth Fishman**

Abstract. Thirty-year old rock reinforcements at the Barron Mountain rock cut along I-93 near Woodstock, NH are the subject of condition assessment and estimation of remaining service-life. Two types of rock reinforcements are installed at Barron Mountain including: (1) partially bonded, resin grouted, prestressed rock bolts, and (2) fully bonded, Portland cement grouted, passive tendons. Phase I of the condition assessment includes an evaluation of site conditions, a review of installation details, estimation of remaining service life and conducting nondestructive testing. The second phase of the project (Phase II) includes lift-off tests; and physical, chemical and metallurgical testing on steel and grout samples retrieved from exhumed reinforcements. Results from Phase II are used to verify results from NDT obtained in Phase I.

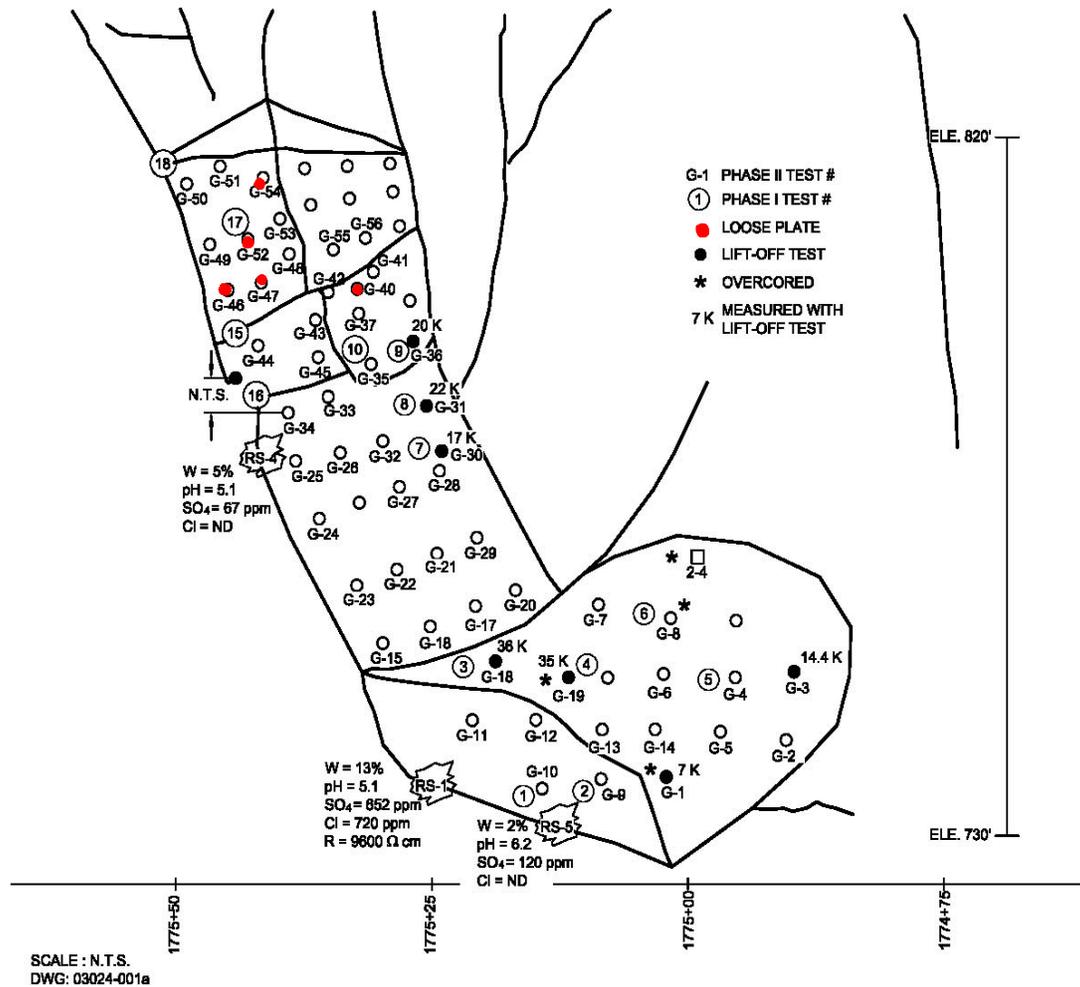
**FIGURE 4. Rock Face Elevation View with Stationing, Reinforcement Locations and Test Numbers for Phase I and II.**

Invasive testing was conducted to verify the results from the nondestructive tests and the service-life estimates. The Phase II invasive Test Program includes some reinforcements with questionable condition, and some reinforcements considered to be in good condition, based on the results from NDT. Seven rock bolts were selected for lift-off tests and three rock bolts and one tendon element were over cored and sampled. Another rock bolt sample was retrieved when a loose block of rock was scaled from the face. Rock bolt and tendon locations included in the Phase II test program are located near Station 1775+00 and are identified in Figure 4.
